## Surface Profile Measurement of Pavement Using Ultrasound

空中超音波を用いた舗装道路の表面プロファイル測定

Matsuyama Kakeru<sup>1†</sup>, Masayuki Tanabe<sup>1</sup>, Hiroshi Okajima<sup>1</sup>, Toshitaka Yamakawa<sup>1</sup>, Miki Sada<sup>1</sup> and Eiichi Funaki<sup>2</sup> (<sup>1</sup>Dep. Eng., Kumamoto Univ.; <sup>2</sup>Gement Inc.)

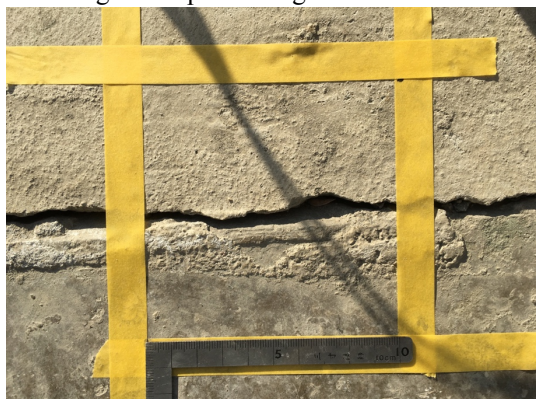
Fig. 6 Picture of smooth surface road with straight crack.

On the rough surface road as shown in **Fig. 4**, the obtained result showed uneven depths in **Fig. 5**. Subsequently, two crack roads were investigated. **Figure 6** shows the smooth road which has relatively simple straight crack. The obtained result from this road illustrate the straight crack even there is still unknown error near the crack point. More complex shape of crack at rough surface road was also investigated as shown in **Fig. 8**. The depth image of the complex crack represents the crack well, as shown in **Fig. 9**. However, the quantitative analyses of them are required to evaluate this system.

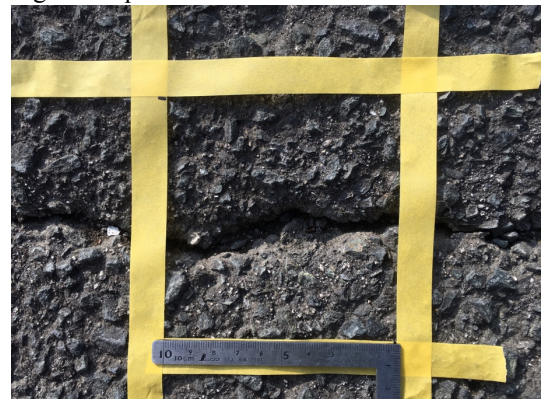
Fig. 8 Picture of rough surface road with complex crack.
