## The detection of reinforced concrete crack caused by corrosion using non-contact acoustic inspection method

### 非接触音響探査法による鉄筋腐食ひび割れの検出に関する検討

Kazuko Sugimoto<sup>1,†</sup>, Tsuneyoshi Sugimoto<sup>1</sup>, Yutaka Kawano<sup>2</sup> and Takayuki Nishido<sup>2</sup>  
(<sup>1</sup>Toin Univ. of Yokohama; <sup>2</sup>IHI Inspection & Instrumentation Co., Ltd.)  
杉本和子<sup>1,†</sup>, 杉本恒美<sup>1</sup>, 河野 豊<sup>2</sup>, 西土 隆幸<sup>2</sup> (<sup>1</sup>桐蔭横浜大院, <sup>2</sup>㈱IHI 検査計測)

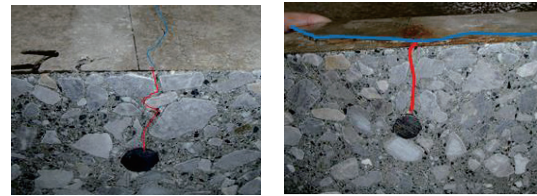
On and near the steel rod (3) in the upper right of Fig. 5, the vibrational energy becomes higher. It is almost at the same position as a crack shown in Fig. 4. The vibrational energy of the steel rod (2) is lower than that of the steel rod (3). In an area shifted to the left from vertical direction of the steel rod (2), the vibrational energy is a little higher than that of the surrounding. In order to ascertain, the test object was cut at the position of the yellow line of Fig. 4. A crack caused by corrosion of the steel rod was obviously confirmed. On the other hand, there is not a corrosion crack in the area of a steel rod (0) and (1). In Fig.6, we can find a crack 0.1 mm in width around the steel rod (2) and a crack of approximately 0.2 mm in width around the steel rod (3). A red crack line towards the concrete surface is shown respectively in the rod (2) and (3) of Fig.6. A surface peeling develops along a blue line in the upper area of the steel rod (3) of Fig. 6.

**Fig.6. The cut cross section of test object.**
